# BioXclude Best of Periodontology – Resident Edition

Blake Crosby, DMD

# Case Presentation

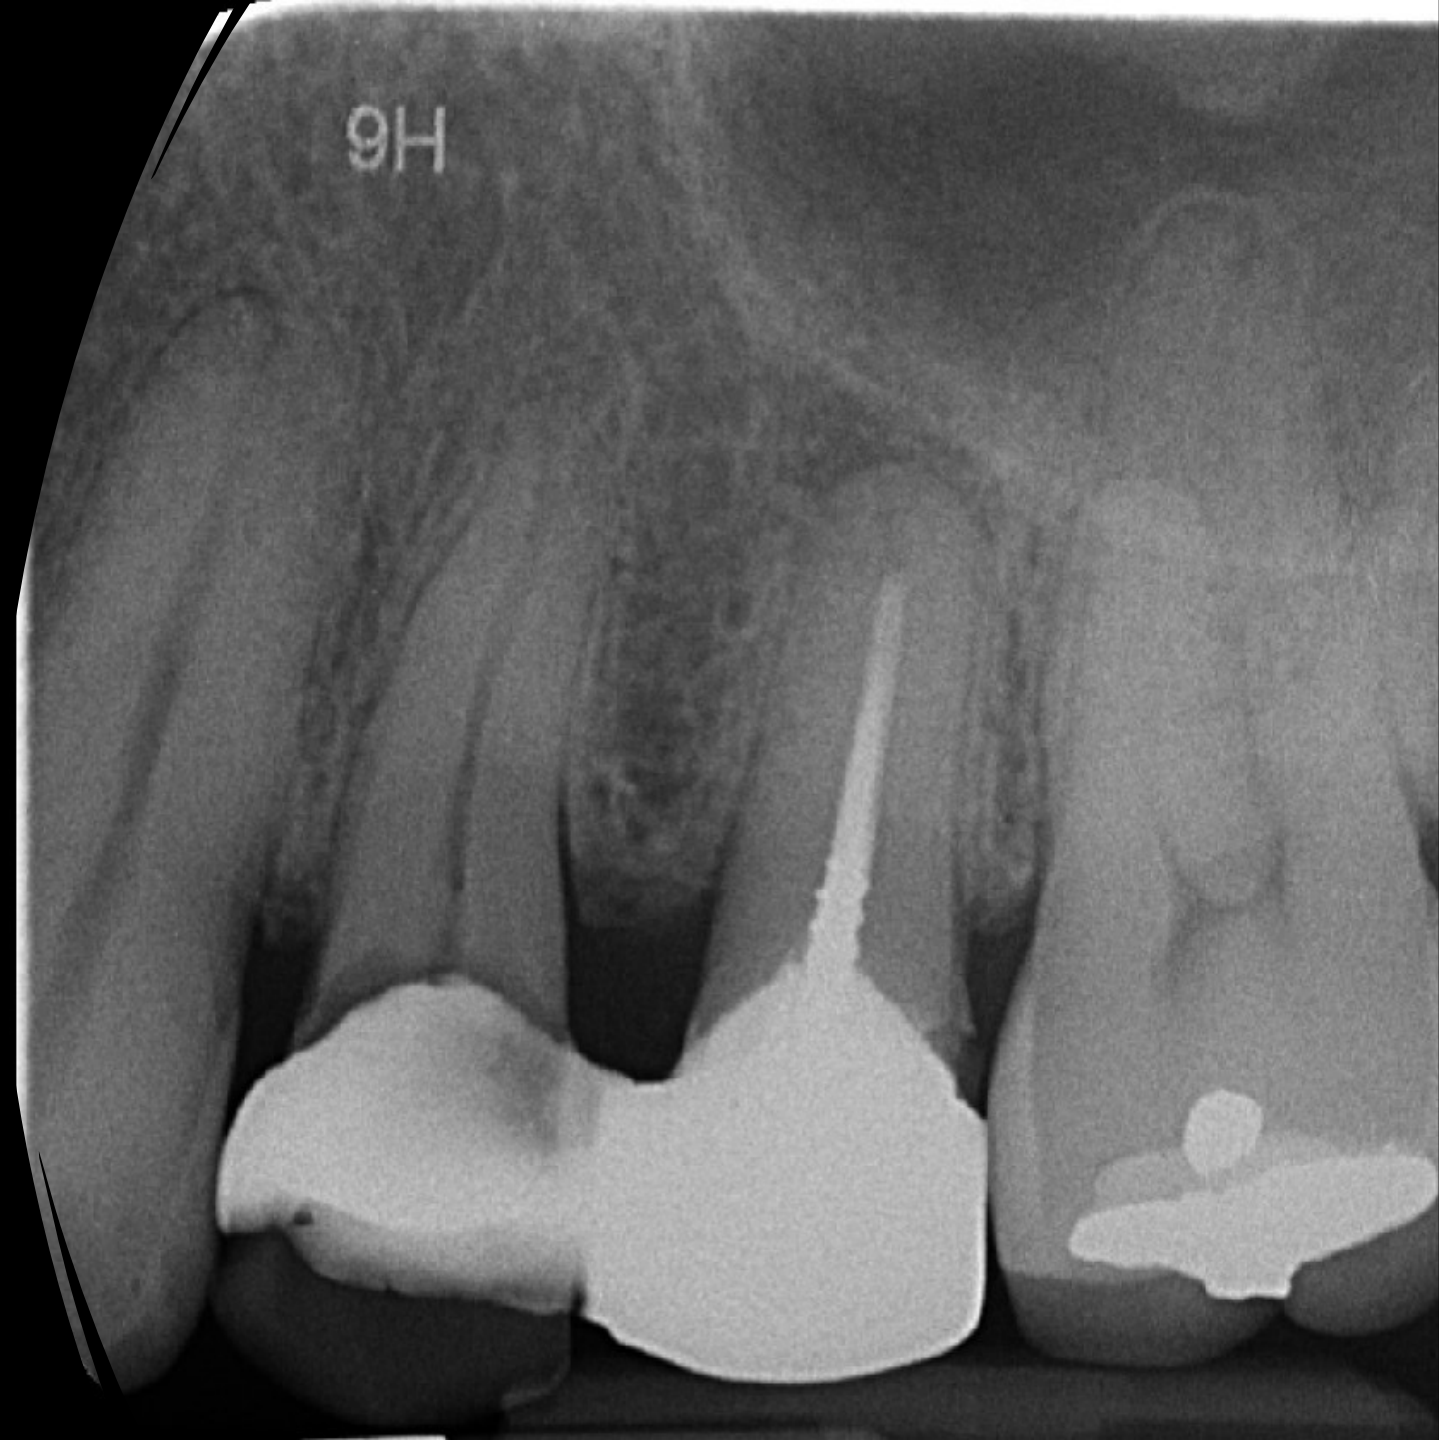
Radiographic  
Interpretation:

- Evidence of secondary decay on #12.
  - Signs of periapical radiolucency associated with previously treated #13.
  - Open margin on the distal of #13.
-

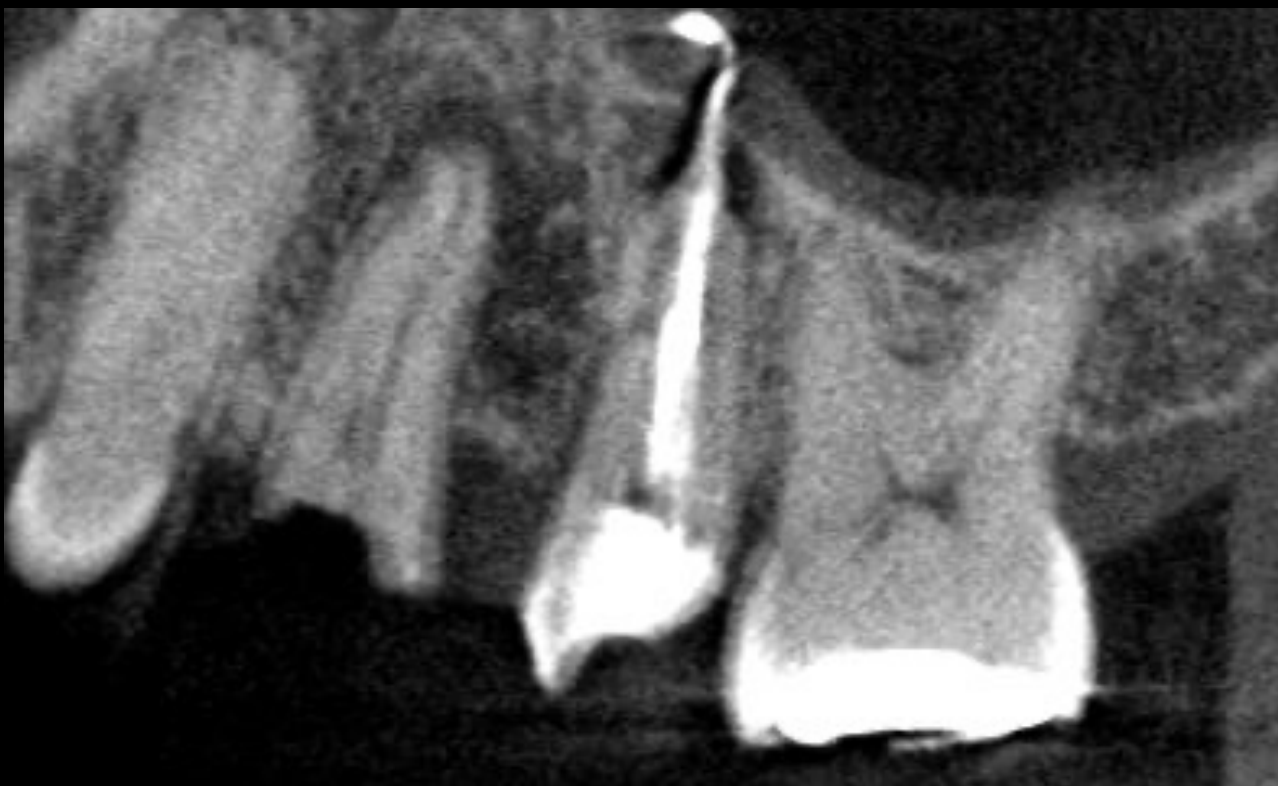
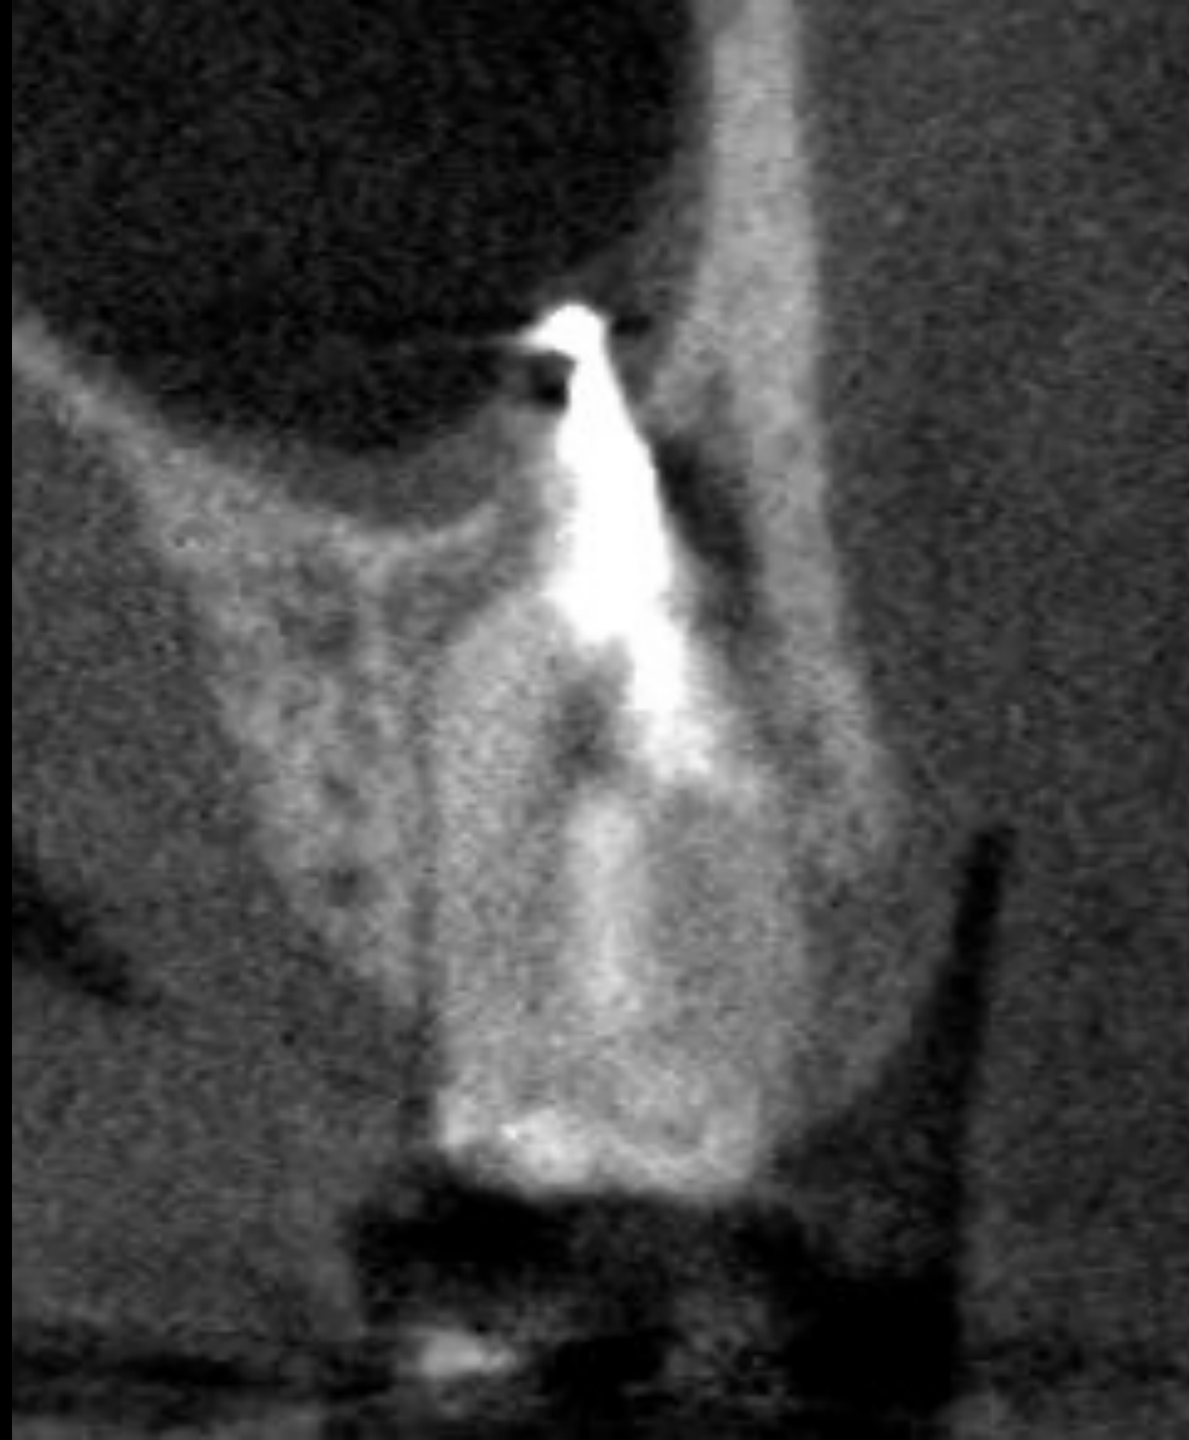
## Endodontic Treatment

- During re-treatment there was a perforation out the apex of #13 and into the sinus. Material extruded according to the endo resident was gutta percha along with MTA.
- After the failed re-treatment, endo and restorative recommended having #13 extracted. Endo also recommended removal of extruded material from sinus.

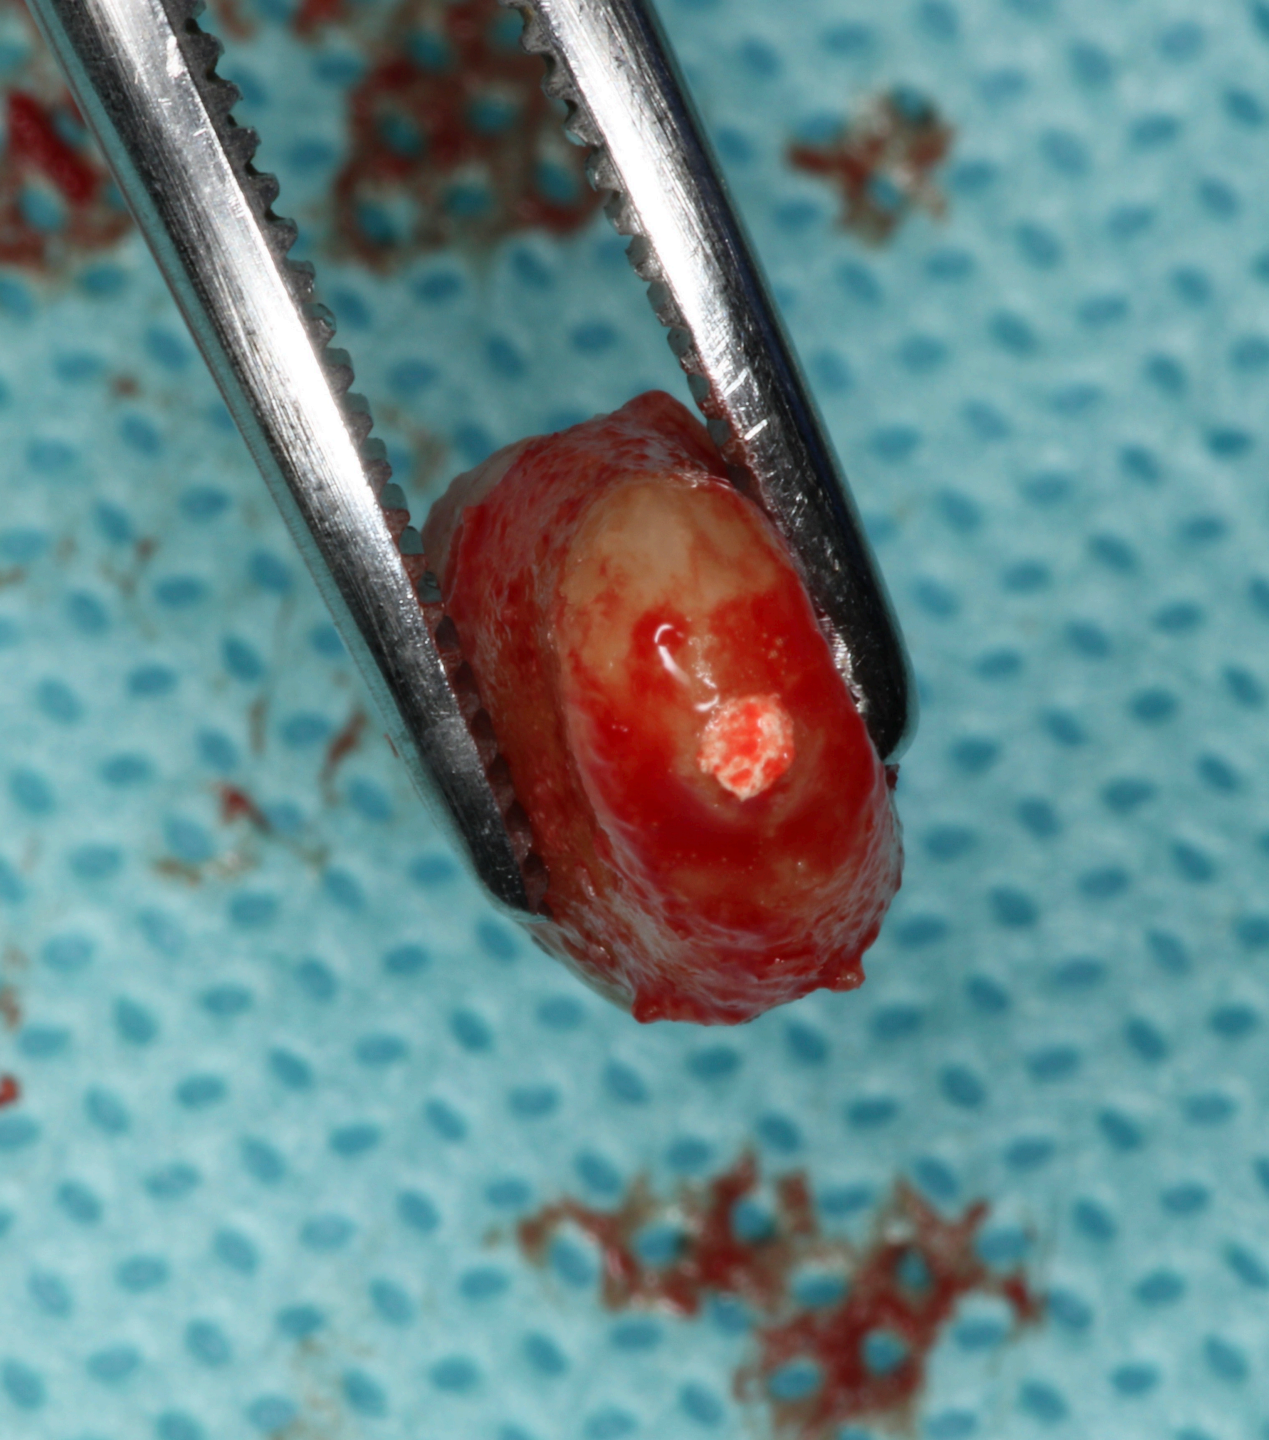
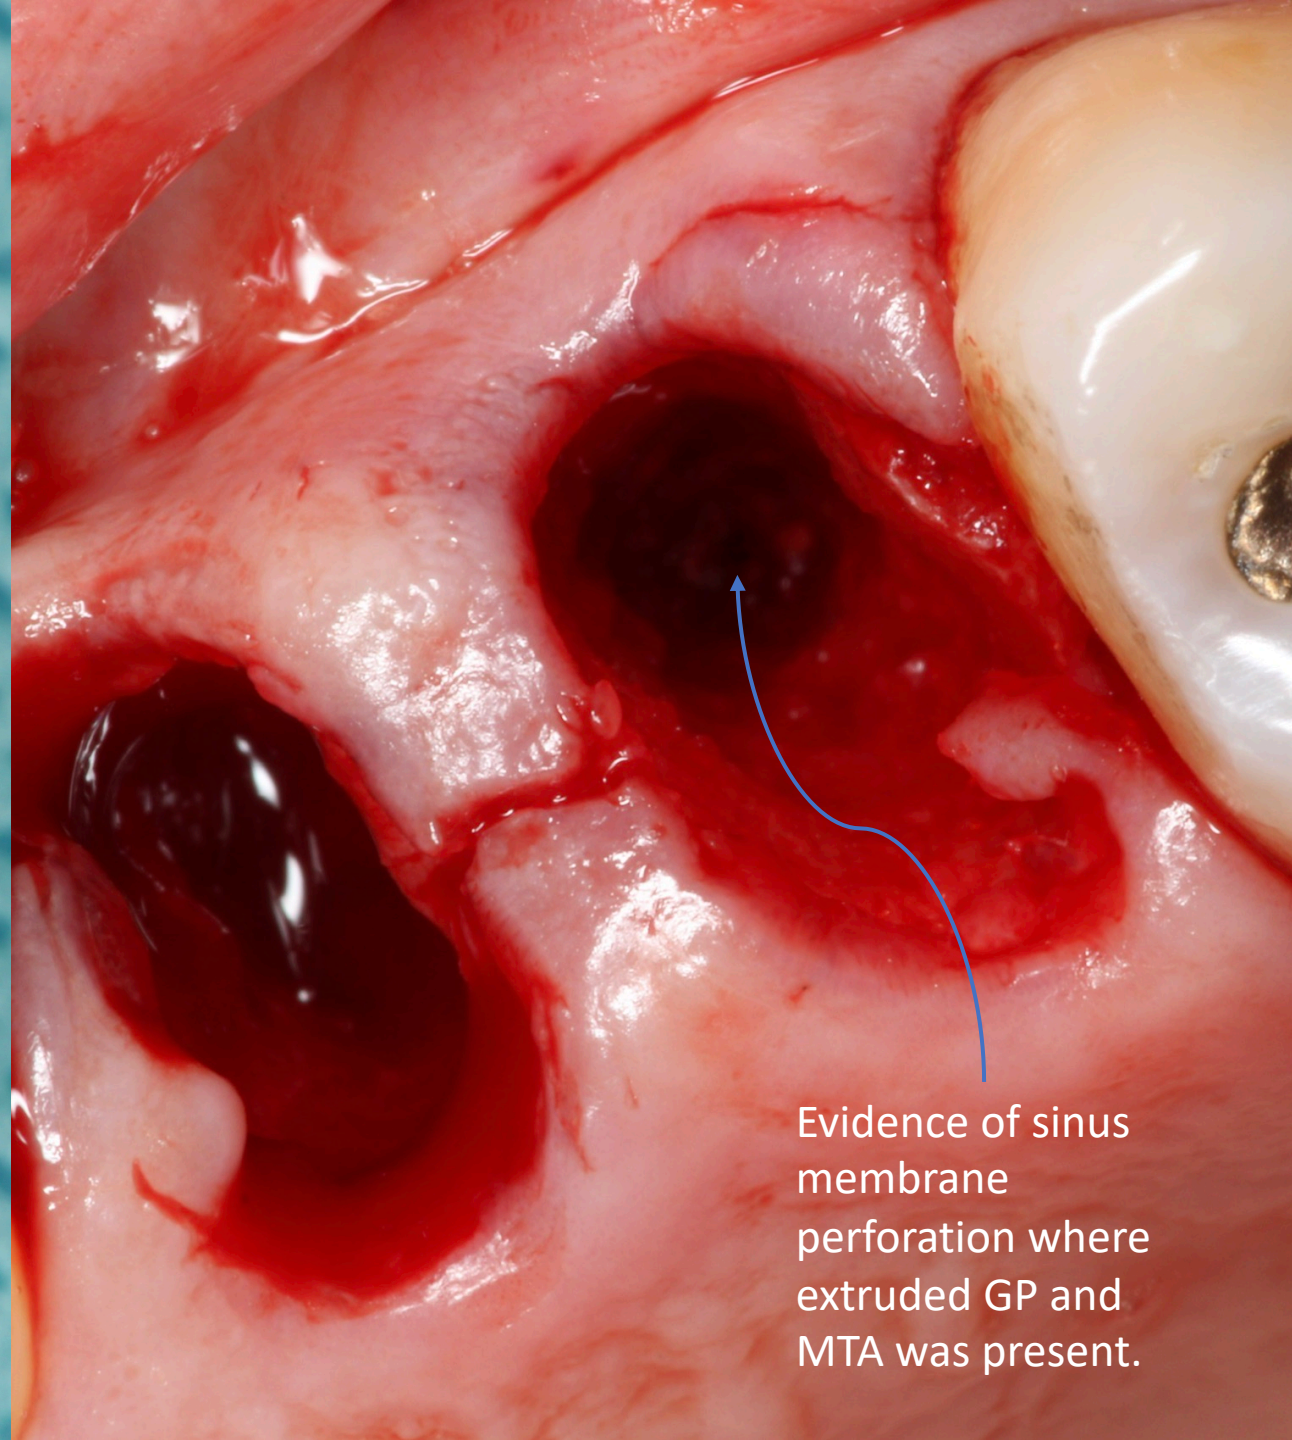
After Extractions

Evidence of sinus membrane perforation where extruded GP and MTA was present.

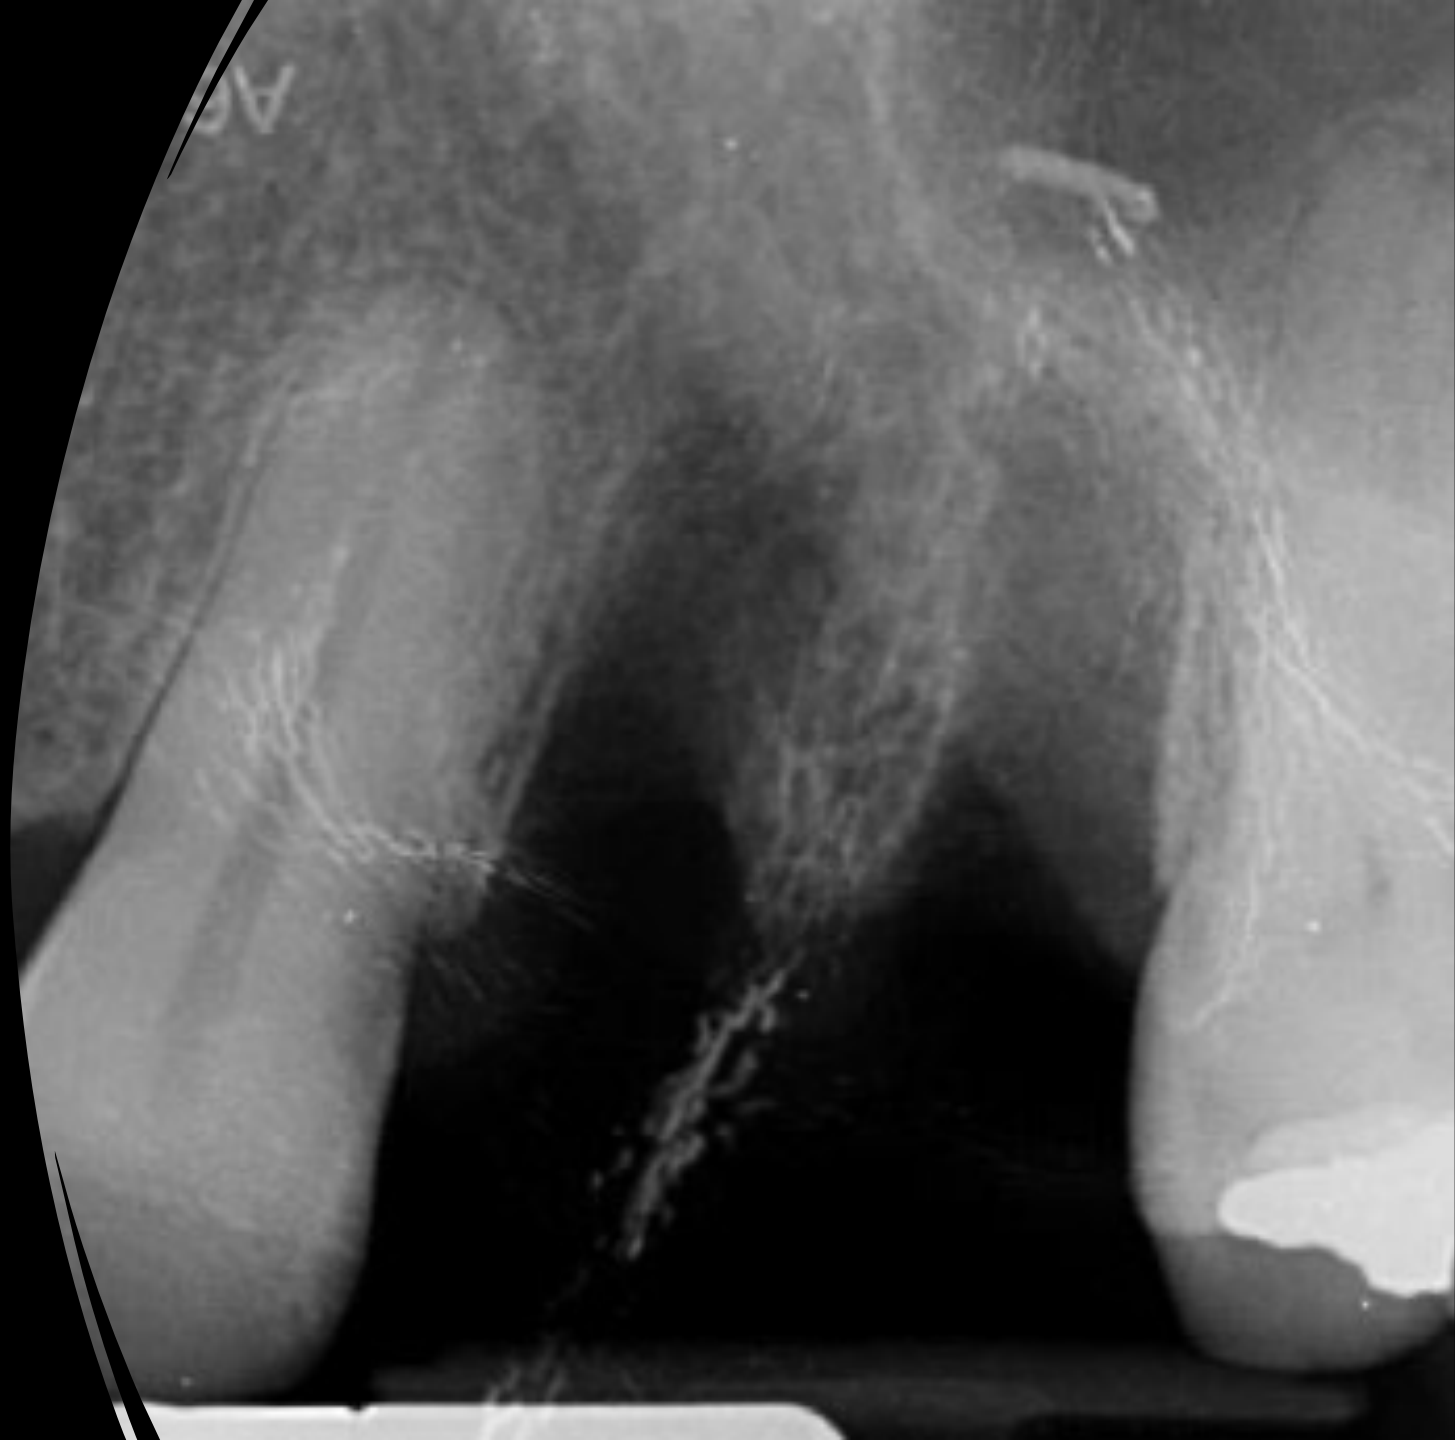
X-ray after  
extractions:  
Notice evidence  
of extruded  
material still  
present.

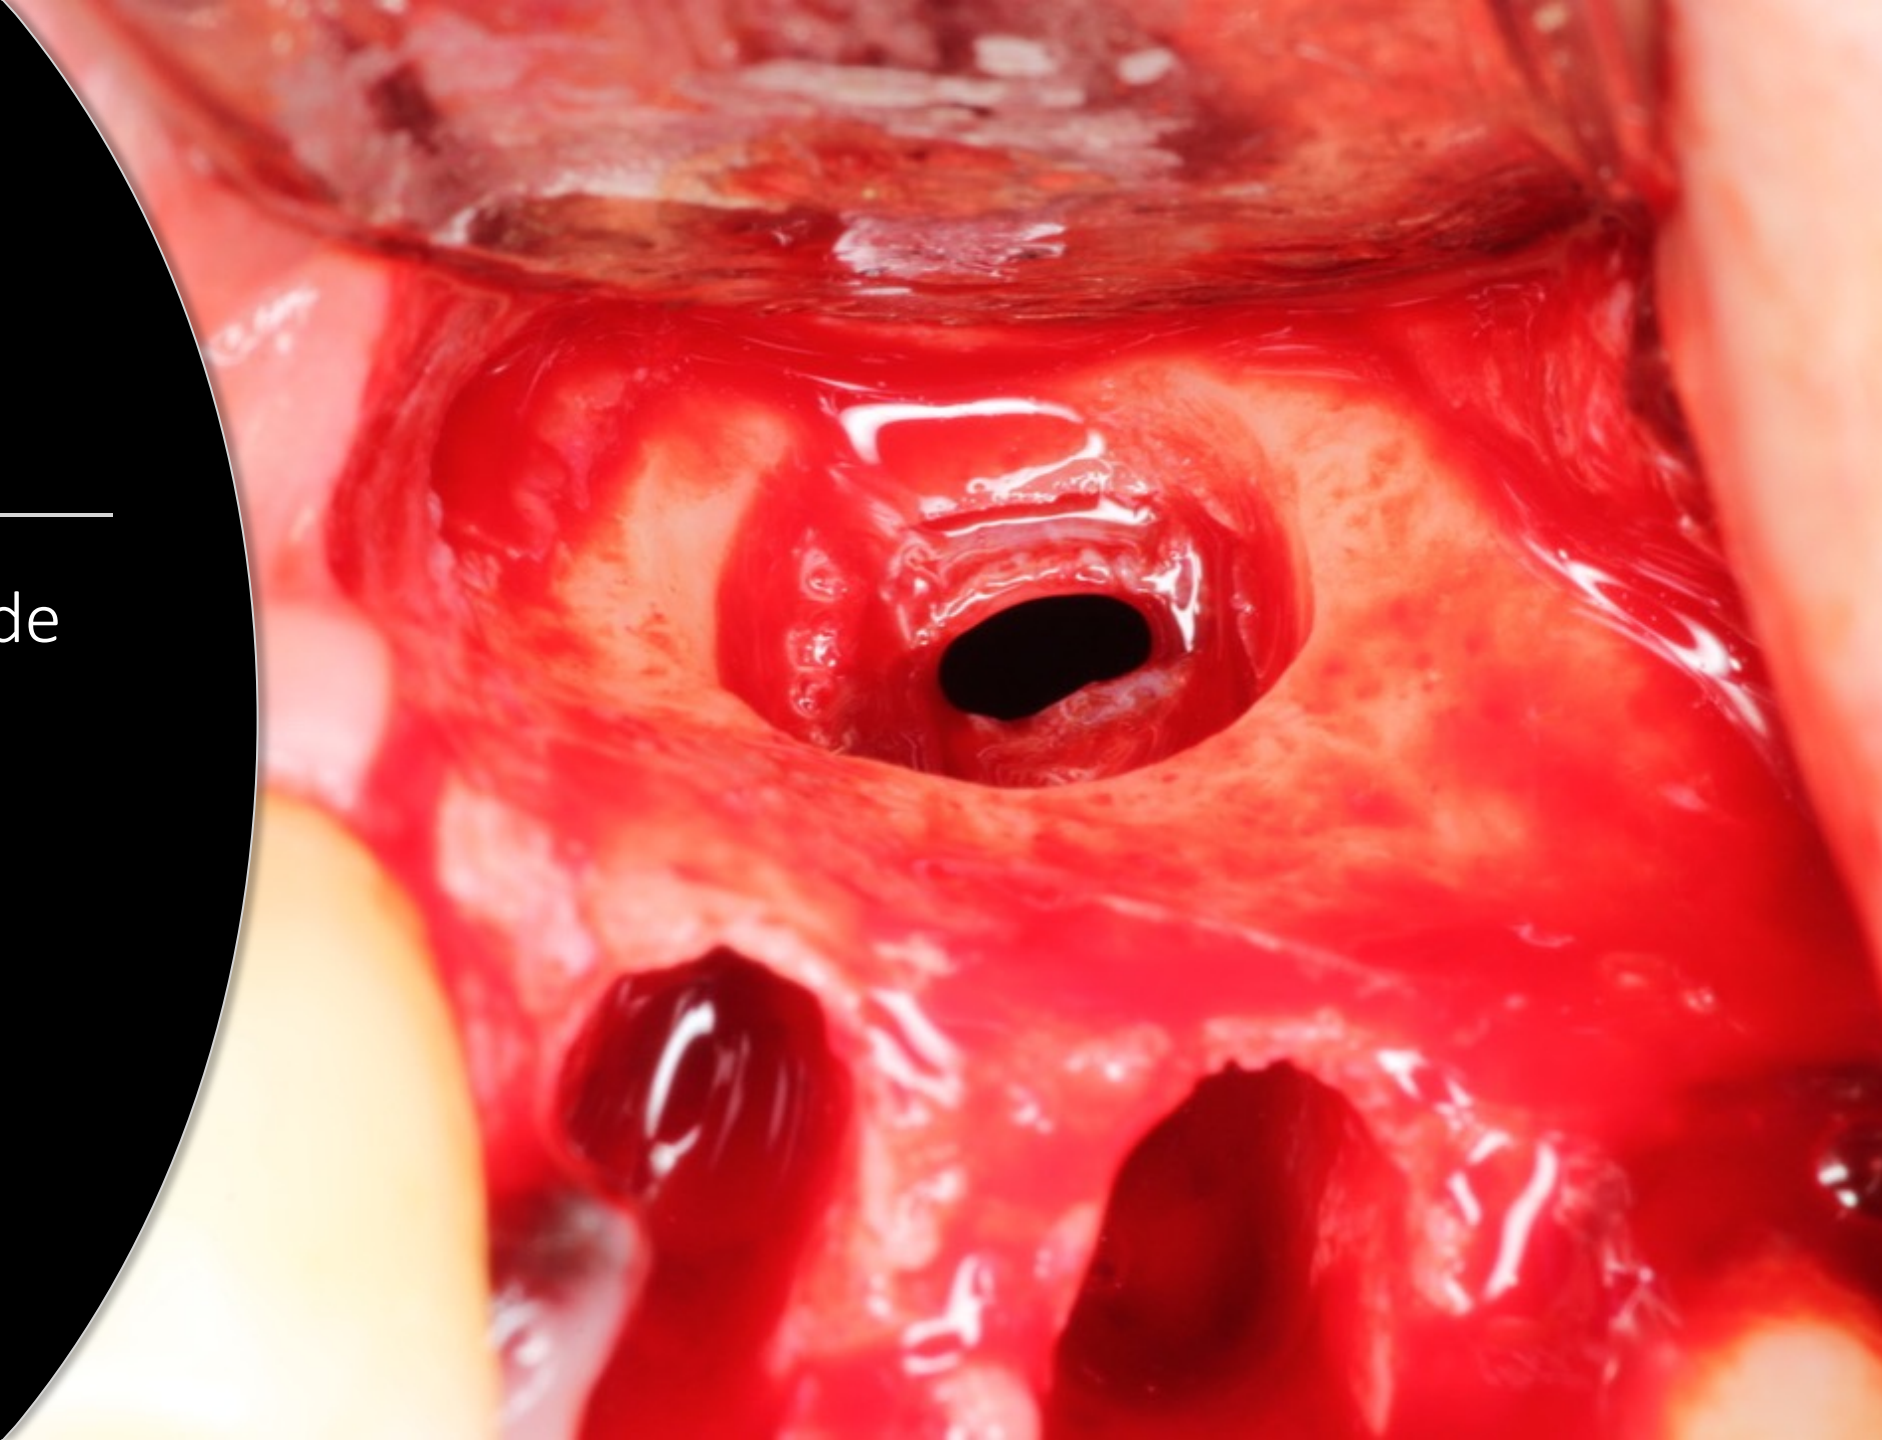
Lateral window made  
and intentional  
perforation created  
using a blade.

- Attempt was made to remove extruded material through the socket without success.
- Decision was made to make a lateral window and intentionally perforate the sinus membrane to remove material (via curette and suction) that is located within the sinus.
- After removing the extruded material, the sinus membrane would need to be repaired using bone and membrane.
- Bone selected was a 70/30 Min/Demin Allograft.
- Membrane selected was BioXclude.
- Note: BioXclude was selected due to its greatly handling properties and ability to adhere and form to the sinus membrane, providing adequate repair of the intentional membrane perforation.

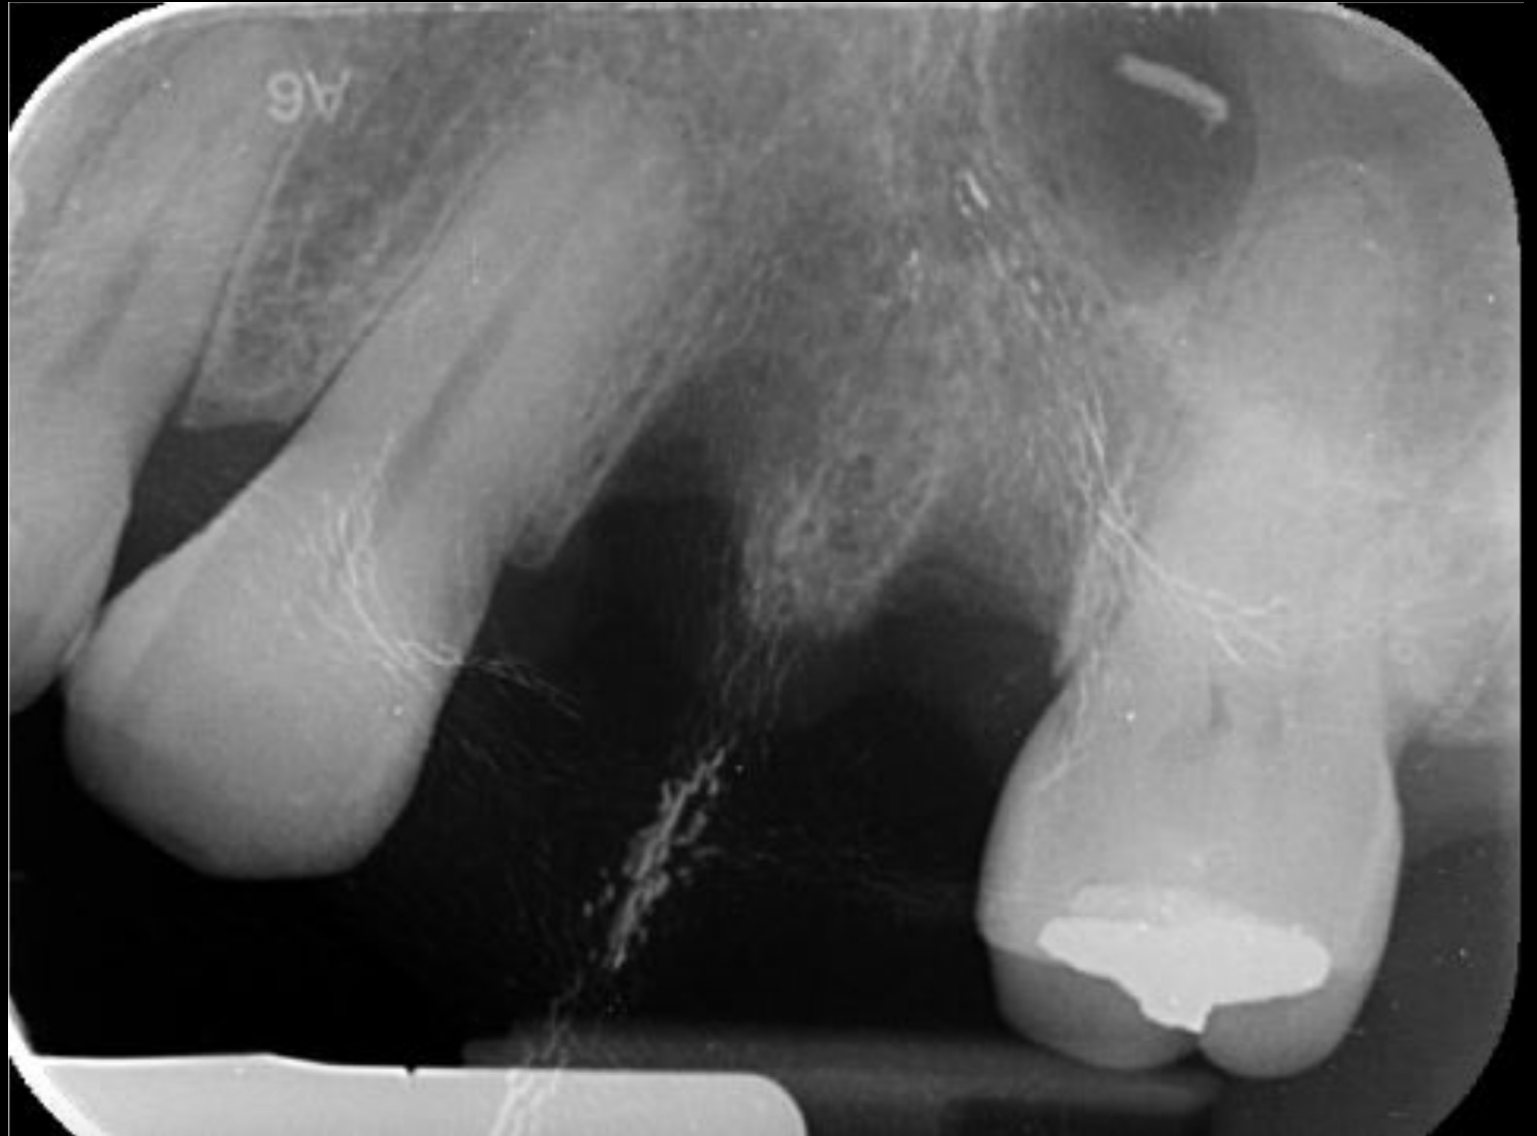
Periapical X-ray  
taken to confirm  
proper location of  
window before  
removal of  
extruded  
material.

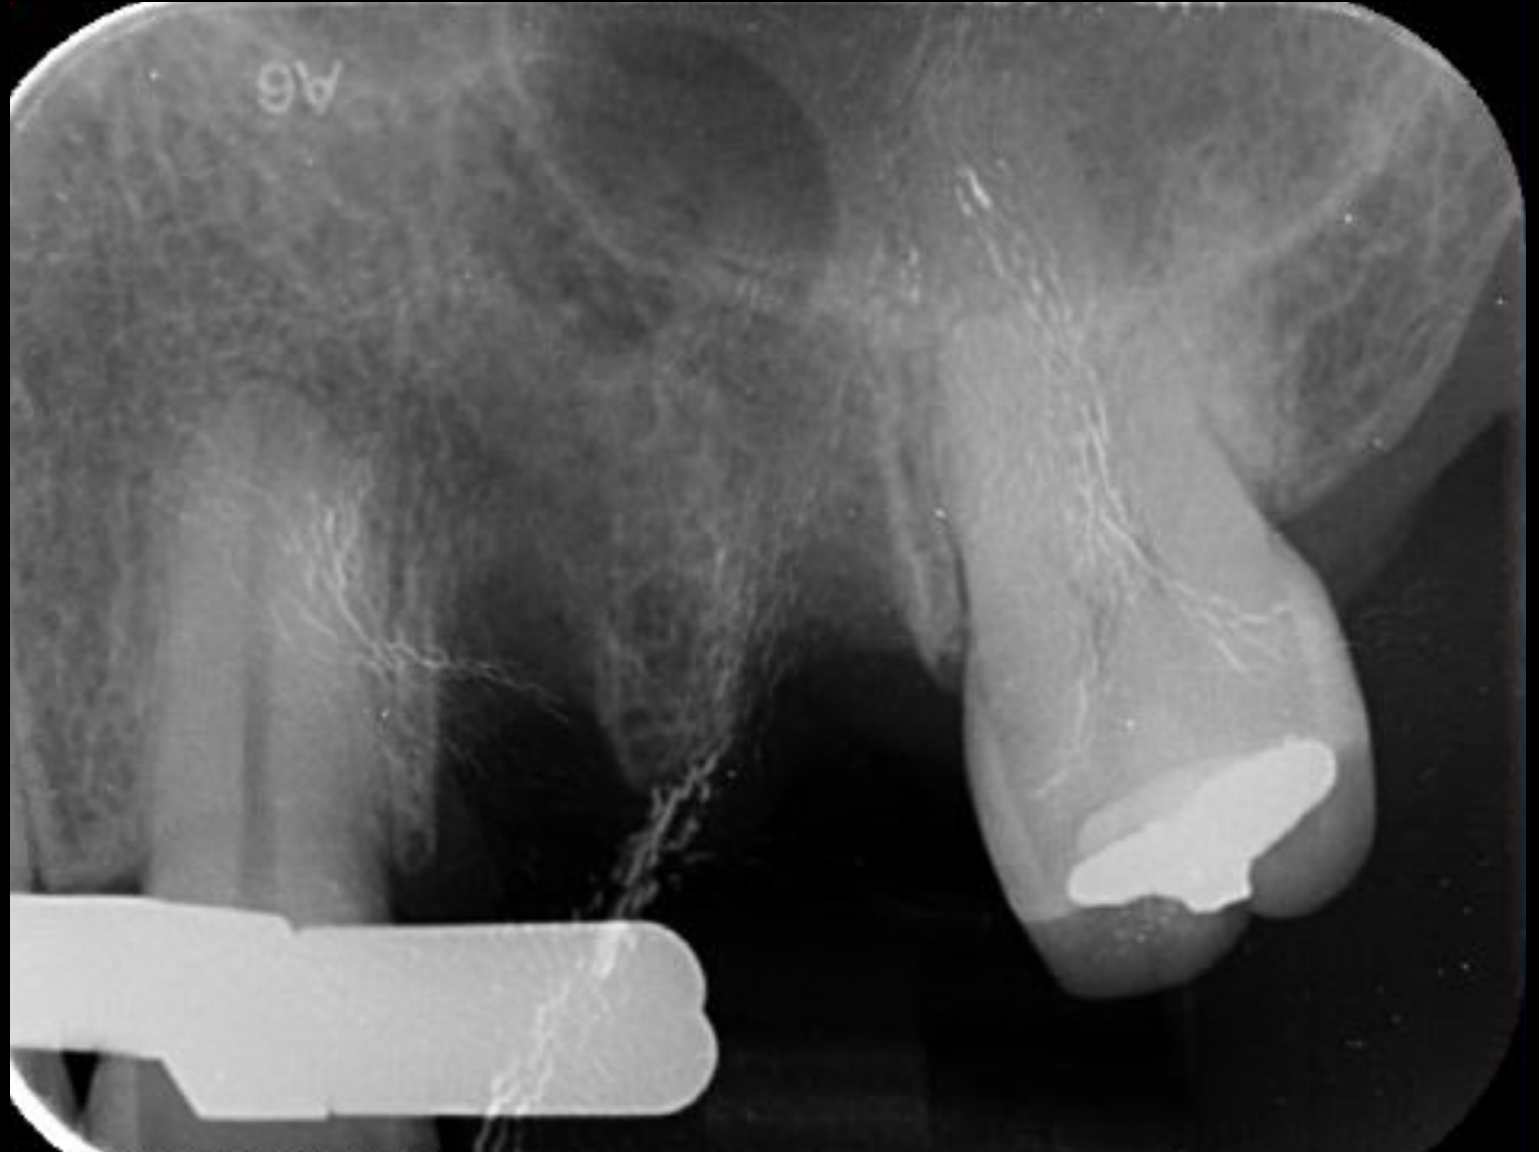
Periapical X-ray  
taken to confirm  
complete removal  
of extruded  
material after  
curettage within  
the sinus.

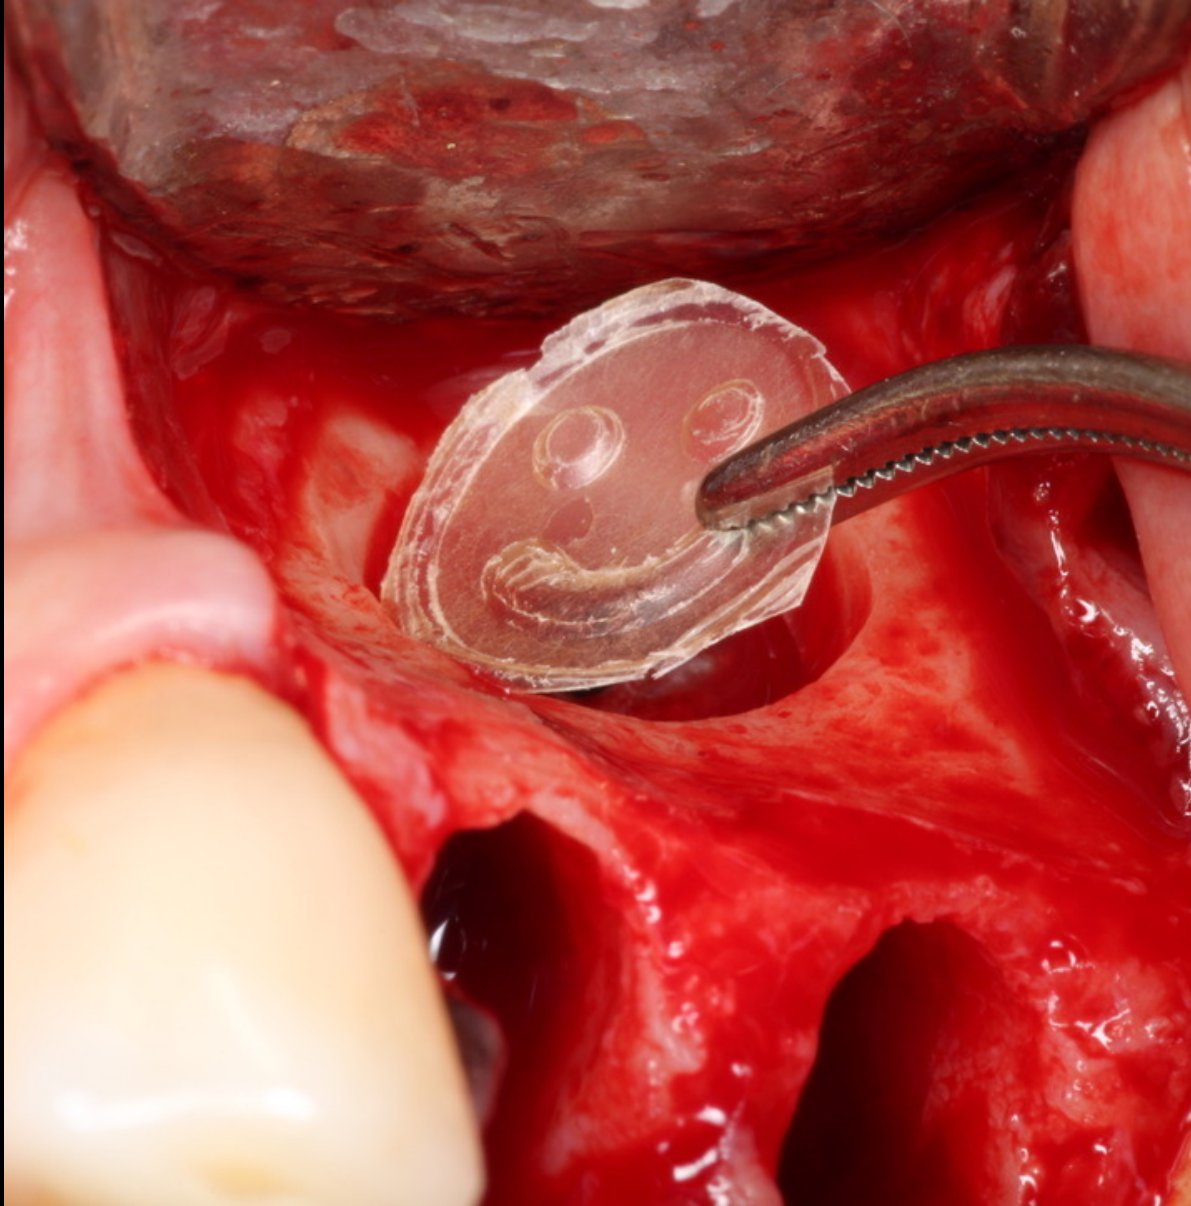
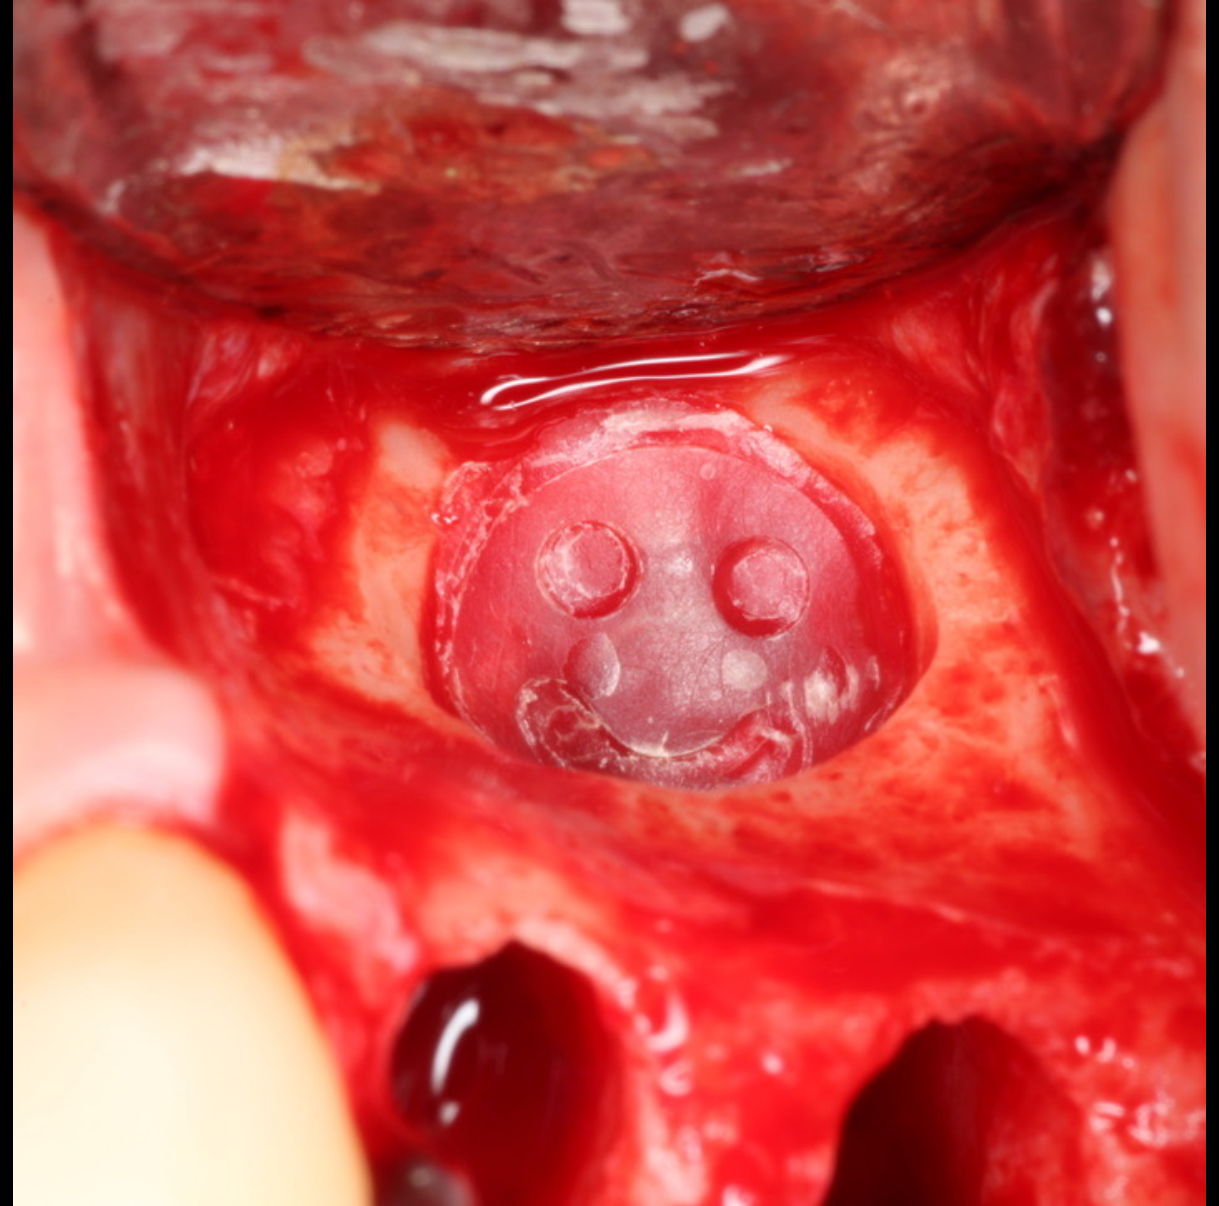
Membrane placed over the perforation.

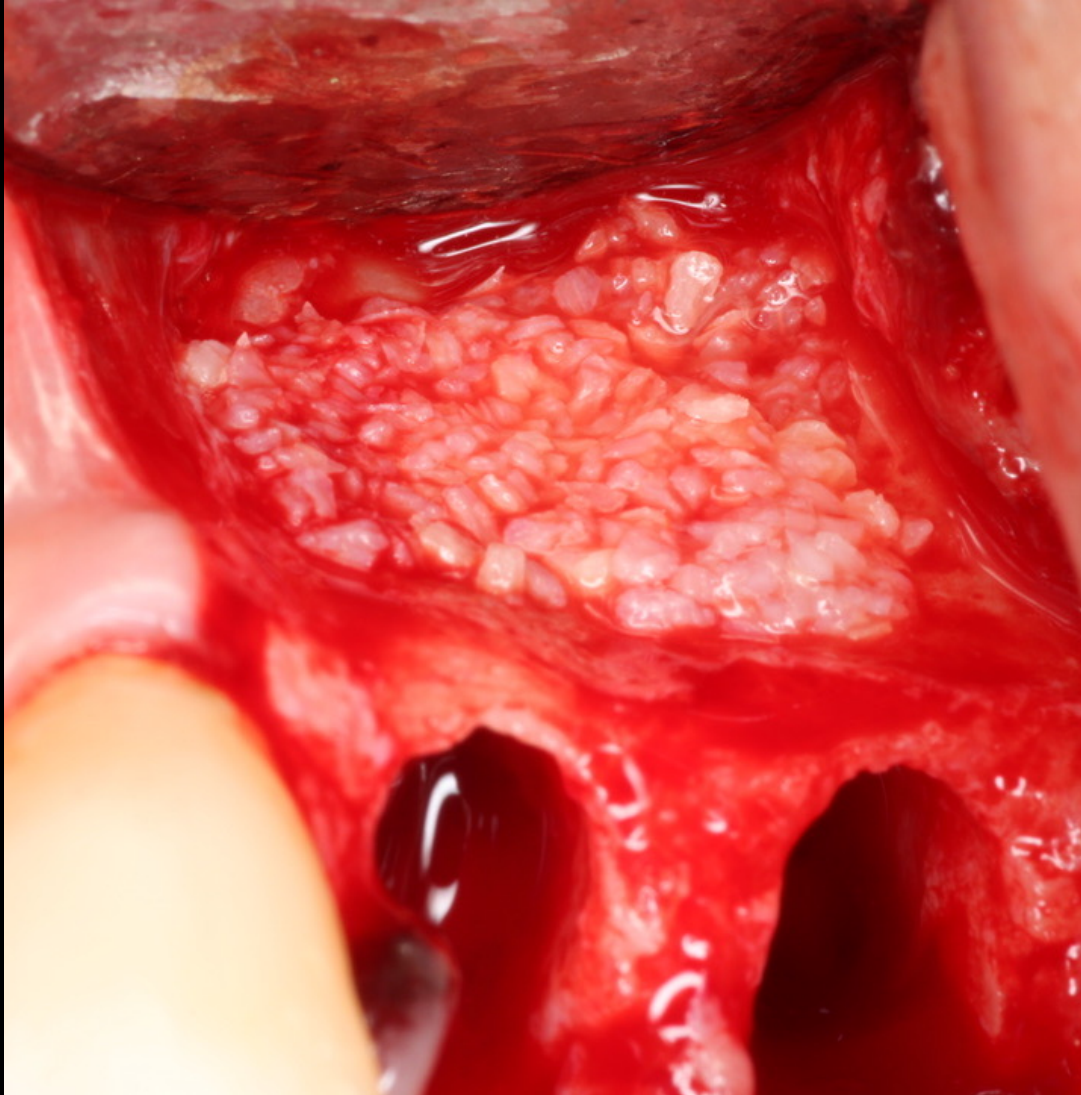
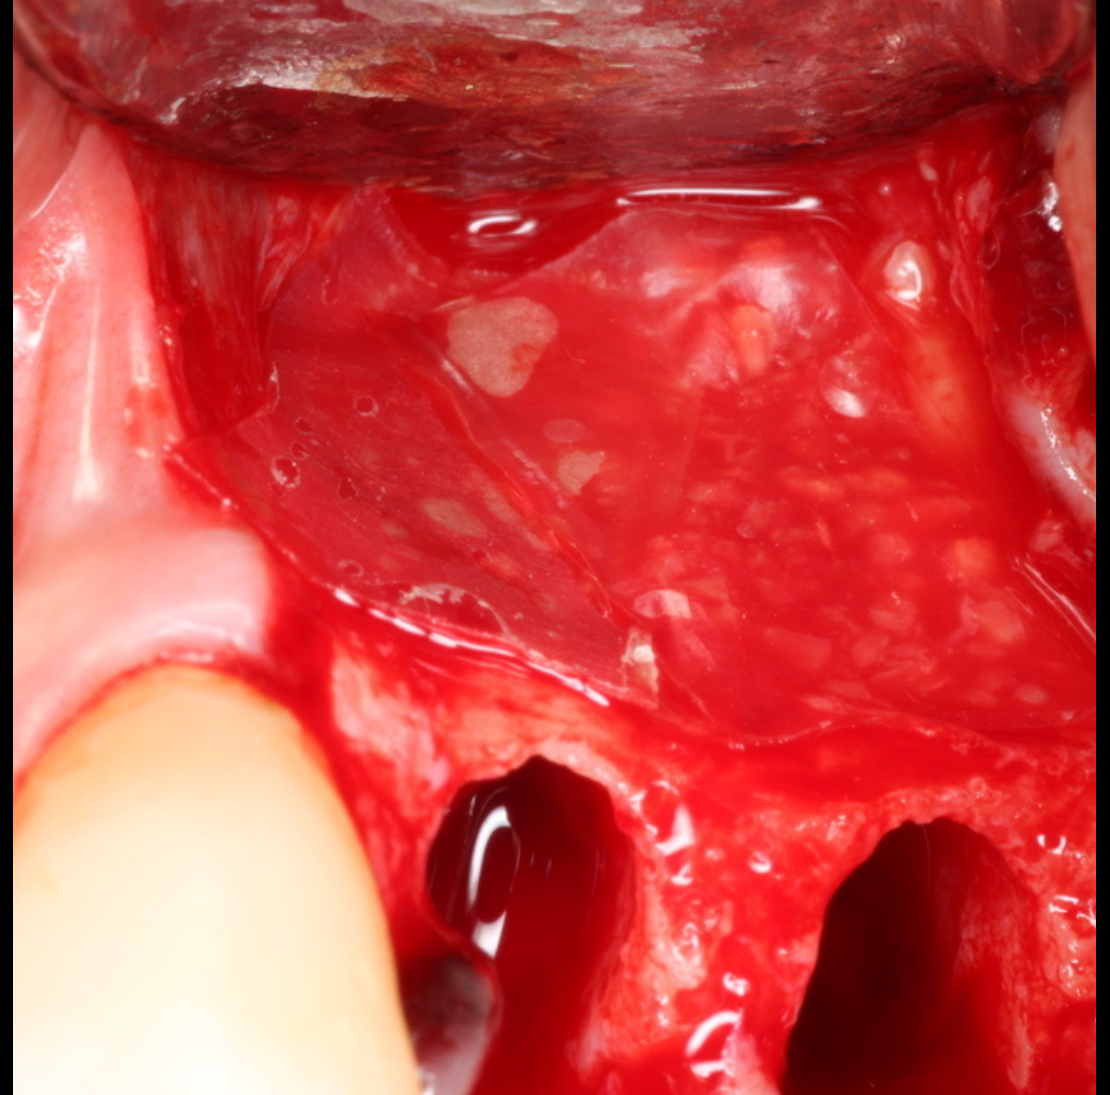
Bone graft and membrane placed over lateral window.
