# BioXclude Best of Periodontology – Resident Edition

Blake Crosby, DMD

# Case Presentation

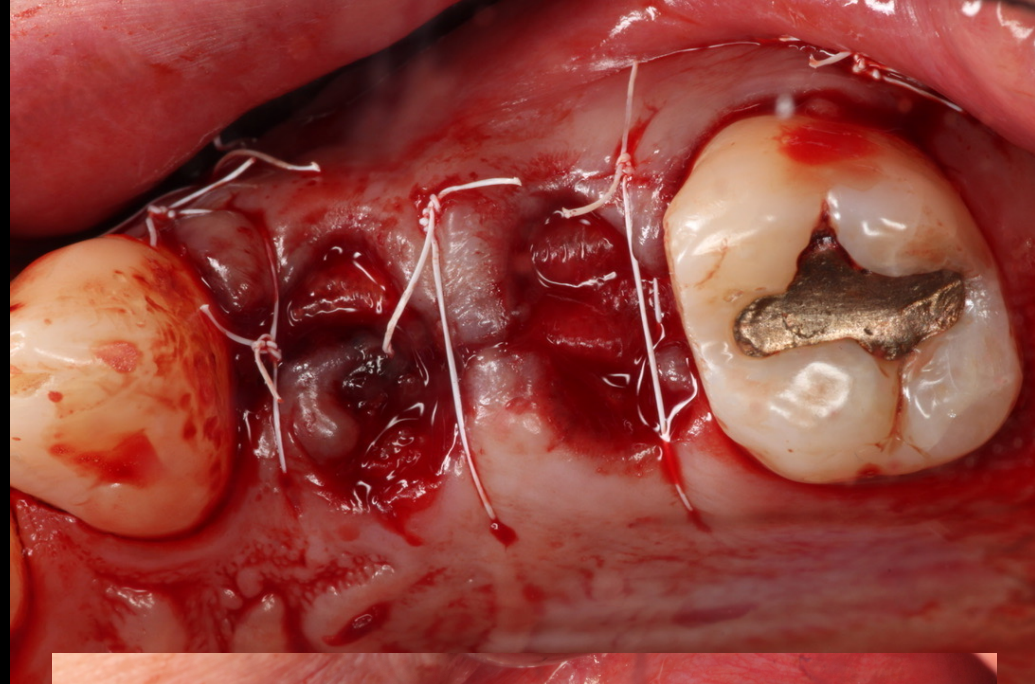
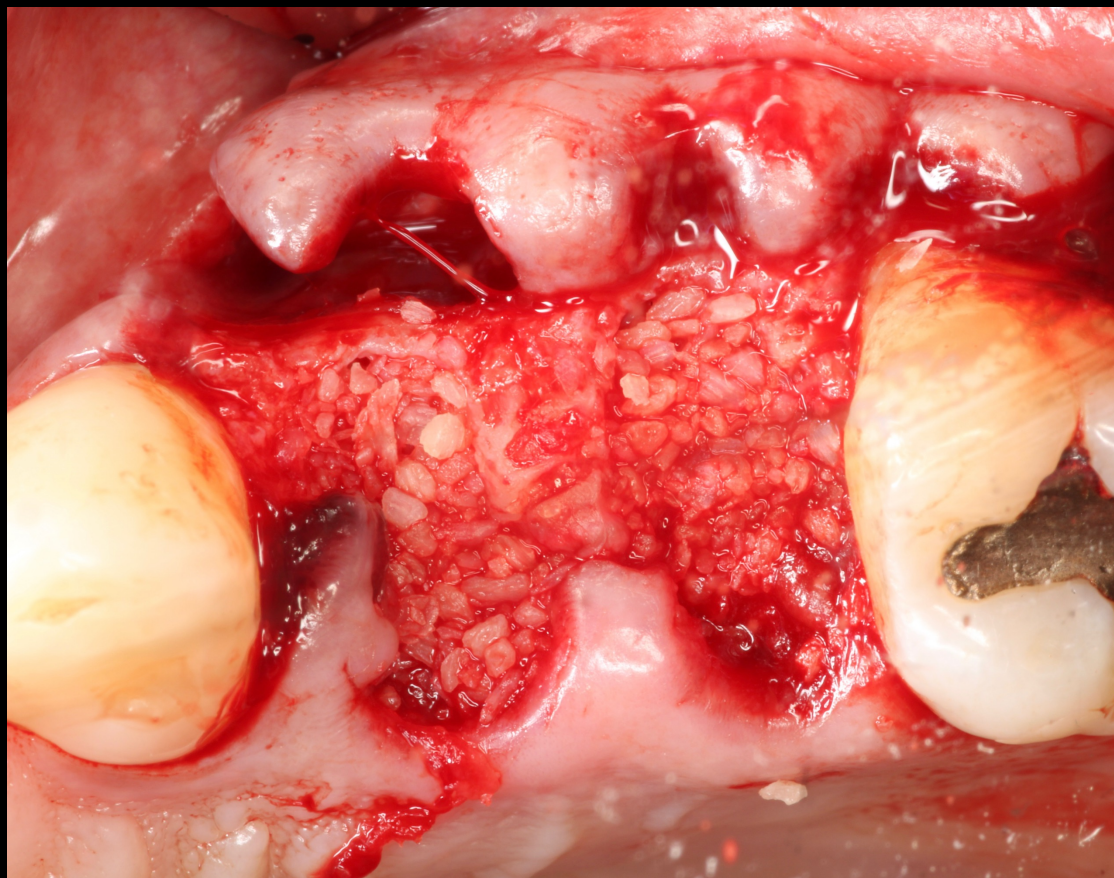
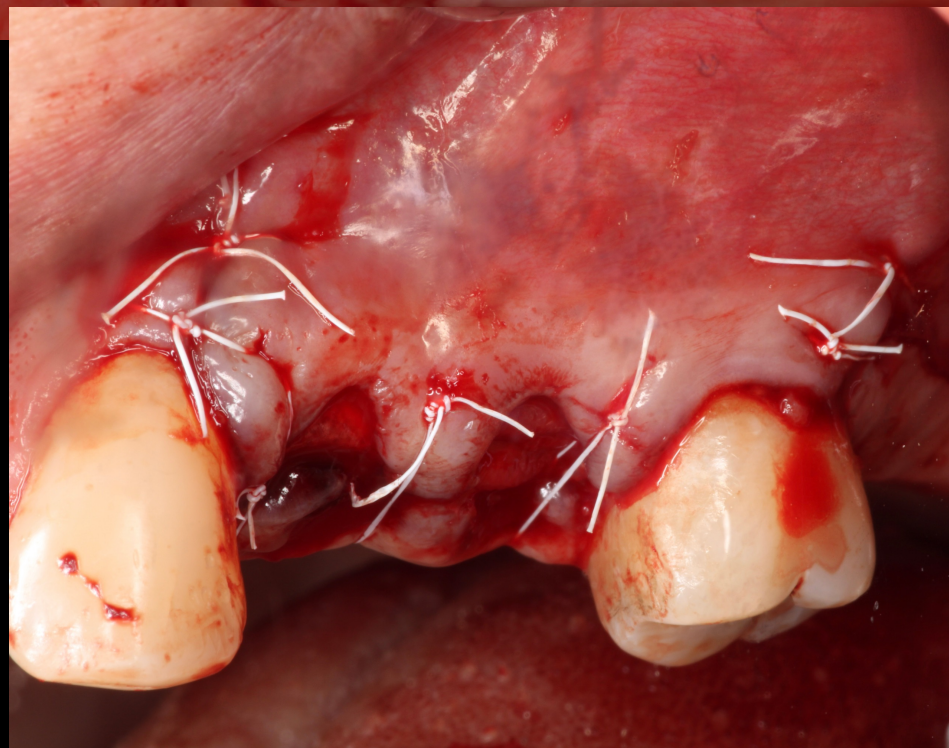
Extraction sockets  
grafted and covered  
with membrane.  
Closure with 4-0  
PTFE.

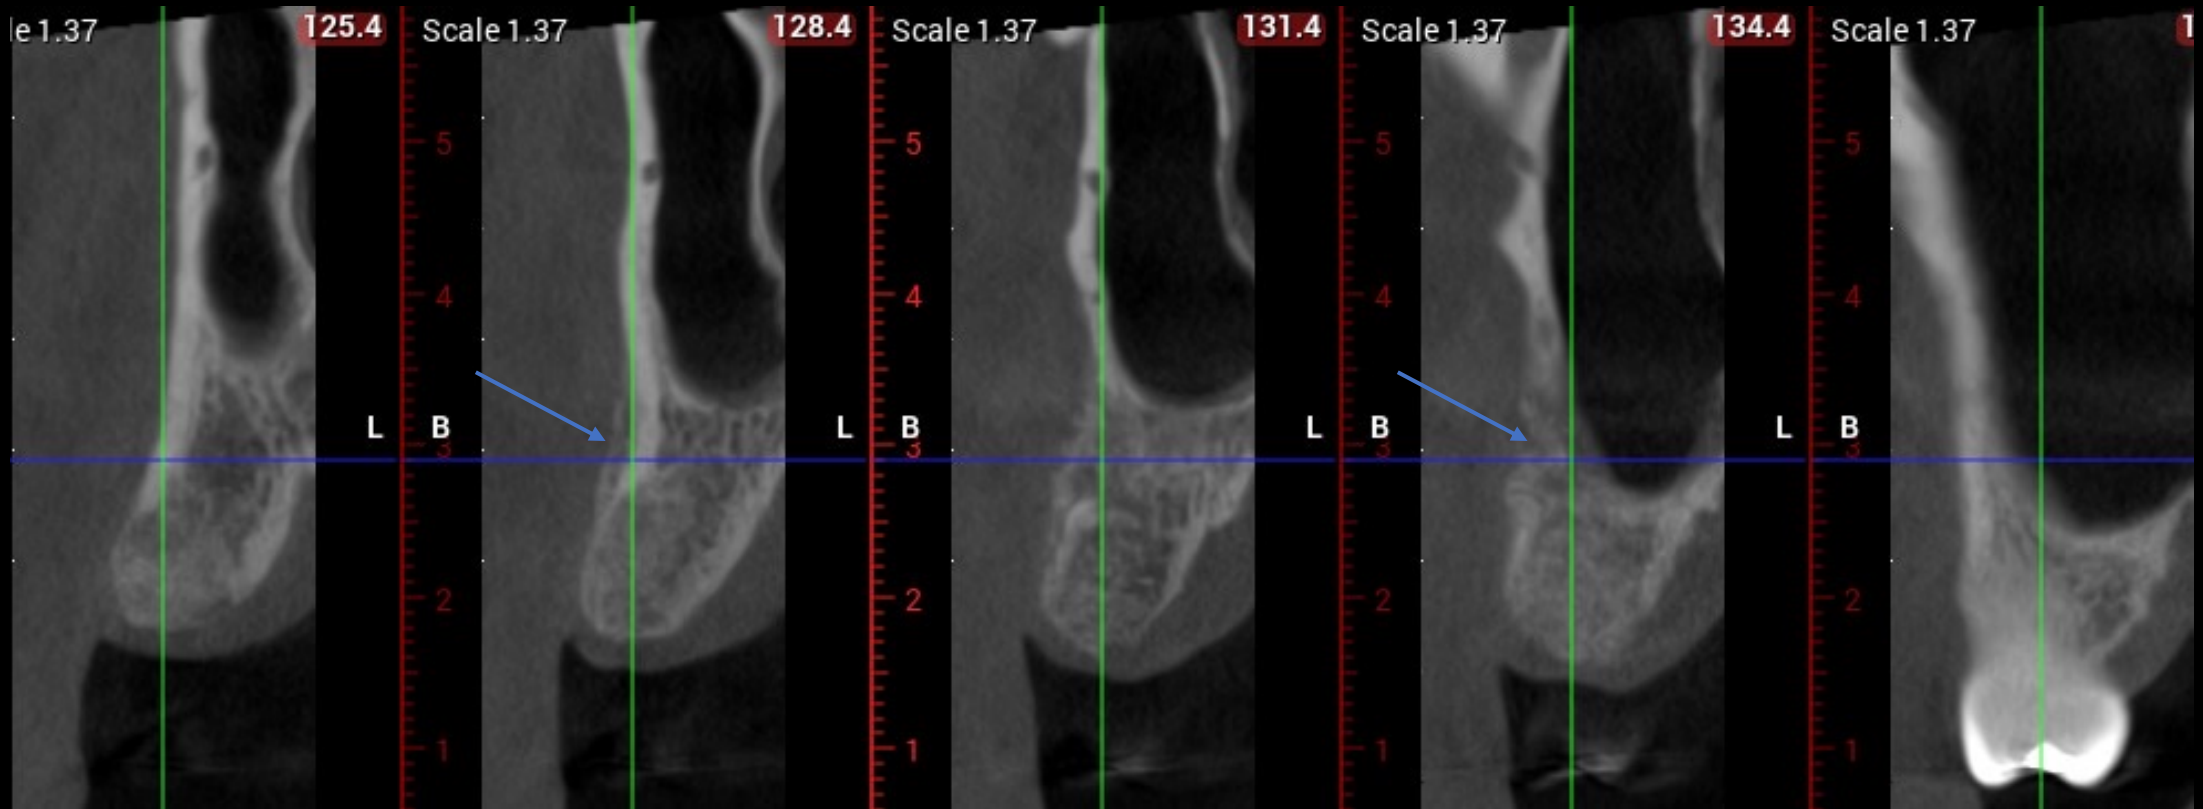
# 4-month CBCT

- Evidence of great healing. Sinus appears wnl and can see evidence of a new cortical plate forming at site of lateral window. Can also see evidence of the well contained buccal grafting over the window. Socket grafting appears to have healed with great trabeculation present. No evidence of any sinus membrane thickening or inflammation.

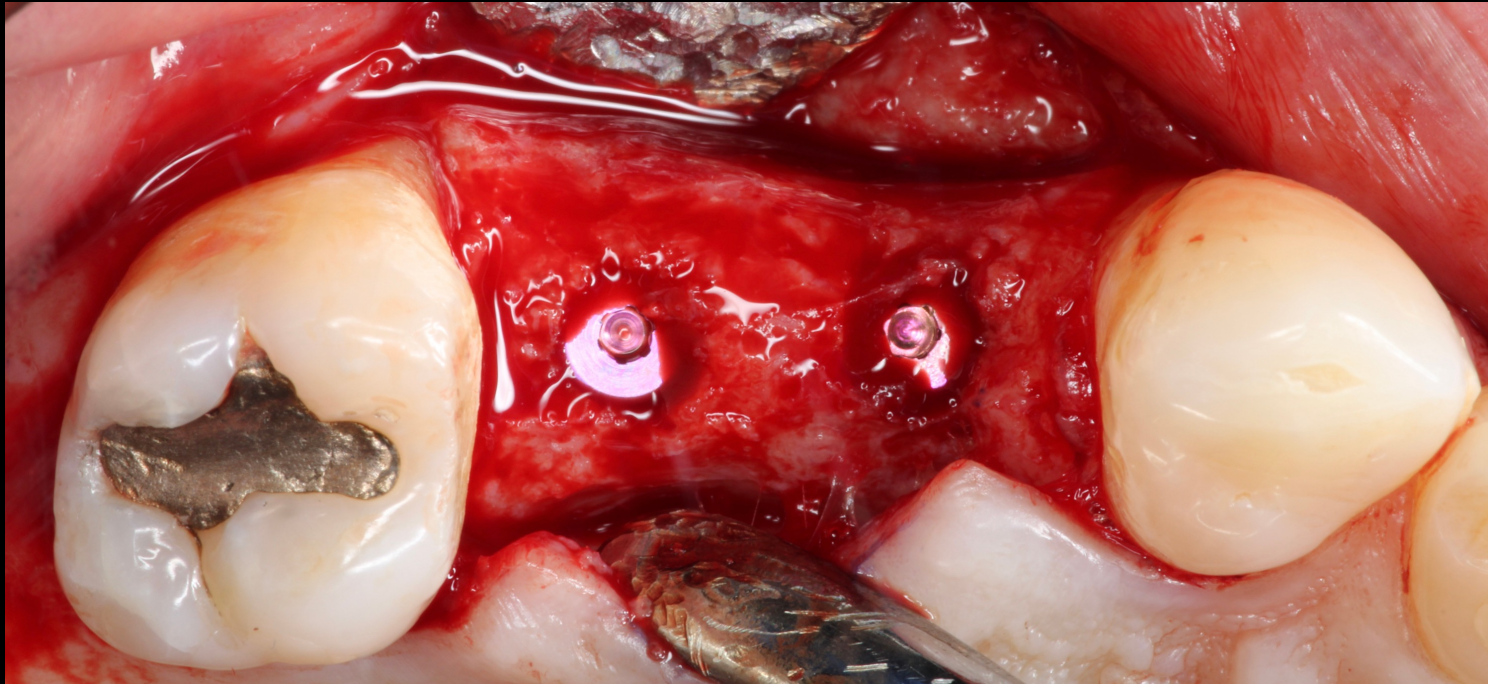
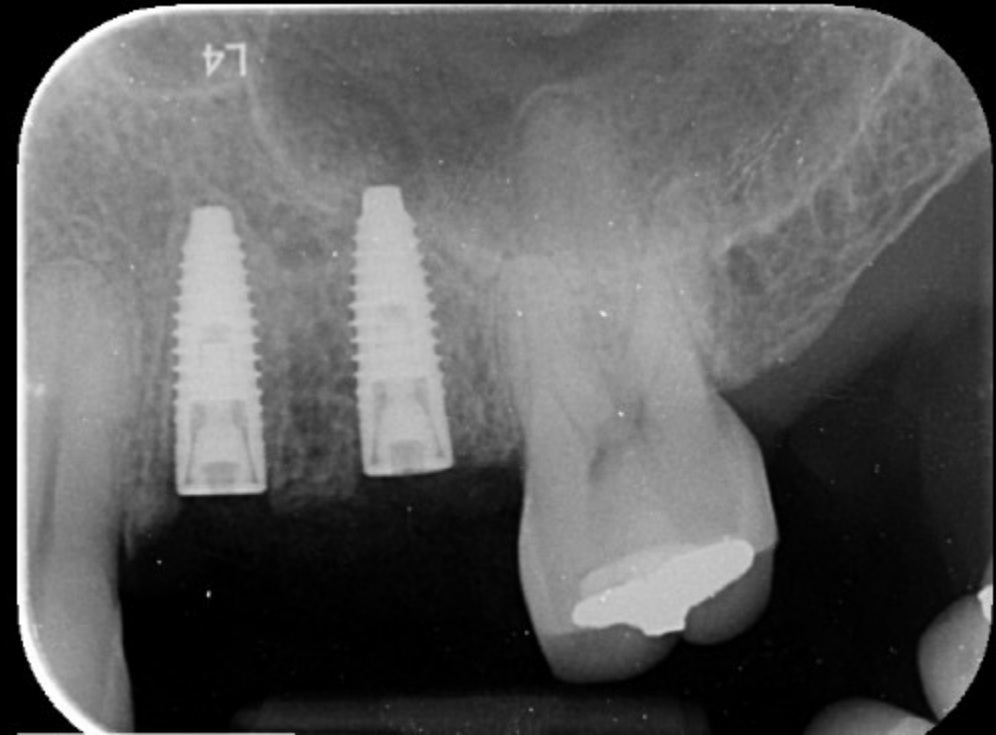
# Guided Implant Surgery – Placement of two Nobel Replace 3.5x10mm implants

Notice presence of vertical internal sinus lift on implant #13.
